PERFORMANCE OF TWO BORON-MODIFIED S-816 ALLOYS IN
A TURBOJET ENGINE OPERATED AT 1650° F

By William J. Waters, Robert A. Signorelli,
and James R. Johnston

Lewis Research Center
Cleveland, Ohio

March 1959

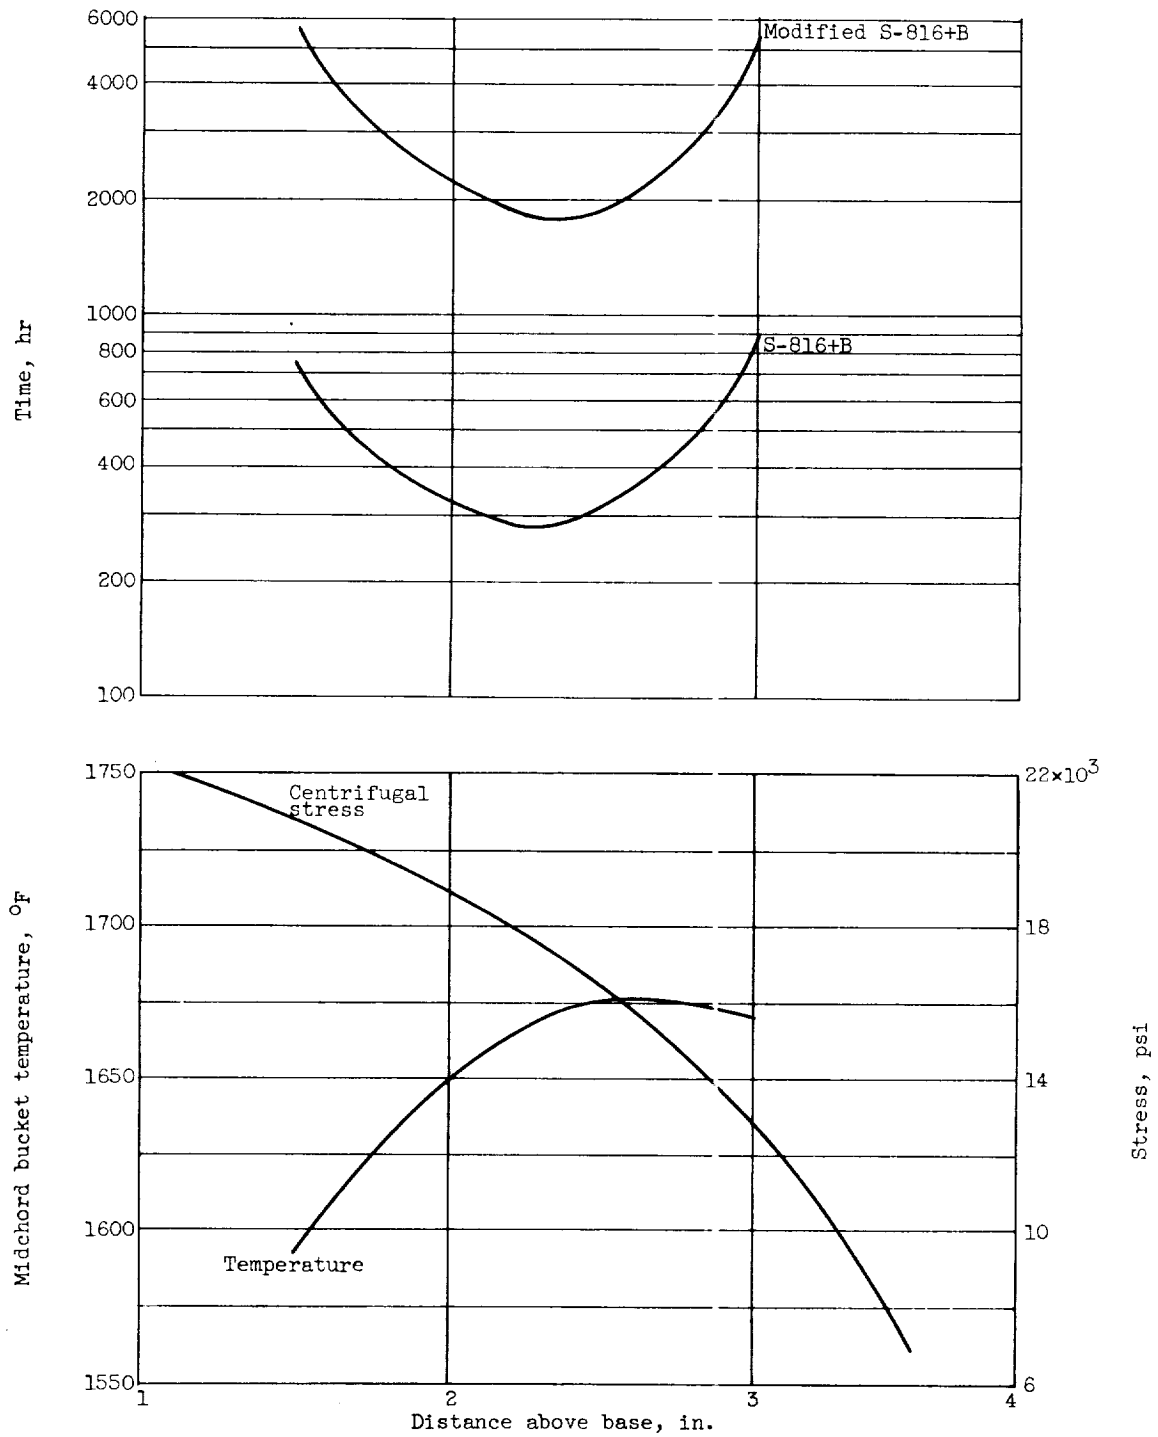
Most of the buckets in this investigation failed very early relative to their potential lives based on stress-rupture considerations alone. The principle cause of bucket failures was mechanical fatigue, which occurred in the airfoil tip. This mechanism not only reduced the life of the majority of buckets of each alloy, relative to its predicted stress-rupture life (280 hr for S-816+B and 1750 hr for modified S-816+B buckets (fig. 1)), but it almost equalized the performance of the two alloy groups. From a practical standpoint, there was no difference in performance of the two groups of buckets, since bucket failures of both alloys began after 10 hours of operation and continued to occur at more or less similar intervals throughout the test. At the time the test was discontinued ($107\frac{1}{2}$ hr) 74 percent of the S-816+B and 58 percent of the modified S-816+B buckets had failed.

Figure 1. - Nominal temperature-stress distribution and minimum stress-rupture lives of bucket airfoils.

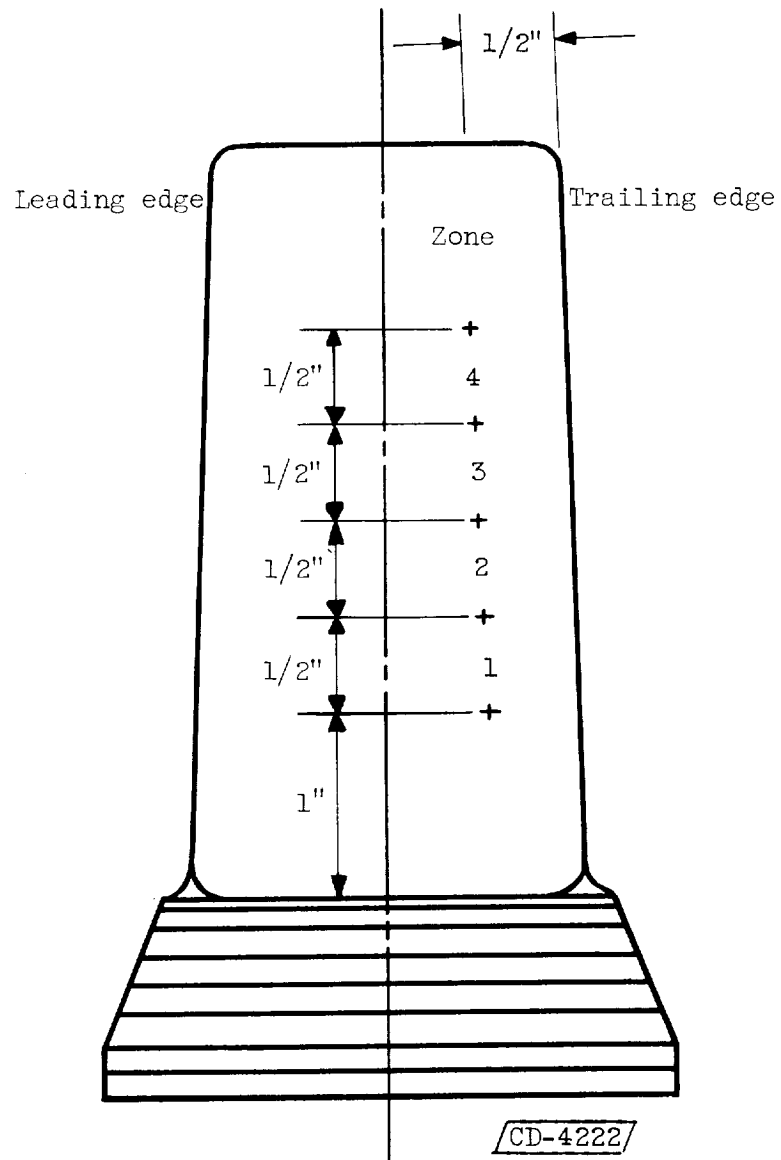
Of the six buckets scribed for elongation measurements, only one of each alloy remained in operation for the entire test. The others had previously been removed because of failure. Figure 10 shows the elongation of the two central zones of the two bucket airfoils during 106 hours of operation. The S-816+B airfoil showed a maximum elongation of 1.1 percent in zone 3. This is greater than the elongation of the modified S-816+B bucket, which elongated approximately 0.7 percent in the same zone.

Figure 2. - Scribed bucket for elongation measurements.

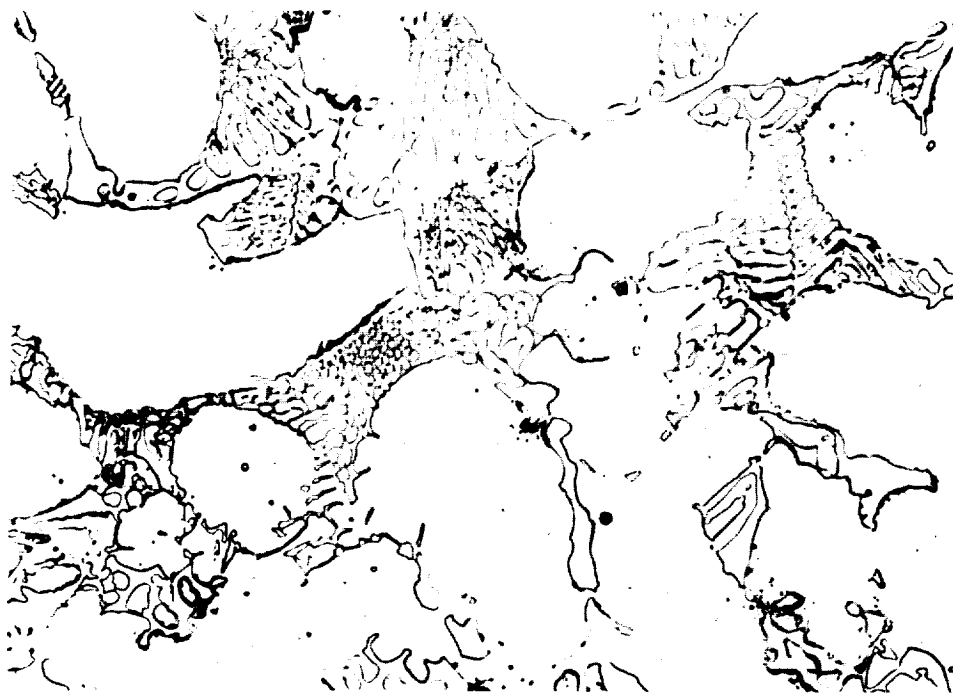
(a) S-816+B.

Photomicrographs of typical as-cast structures of the two alloys are shown in figure 11. Except for the more massive carbide and boride network and the slight amount of precipitation in the matrix of the S-816+B alloy, the as-cast microstructures of both alloys appeared quite similar.

Figure 11 . Typical as-cast structures of alloys. Etchant, 20 cc water, 20 cc glycerine, 10 cc nitric acid, and 5 cc hydrogen fluoride.

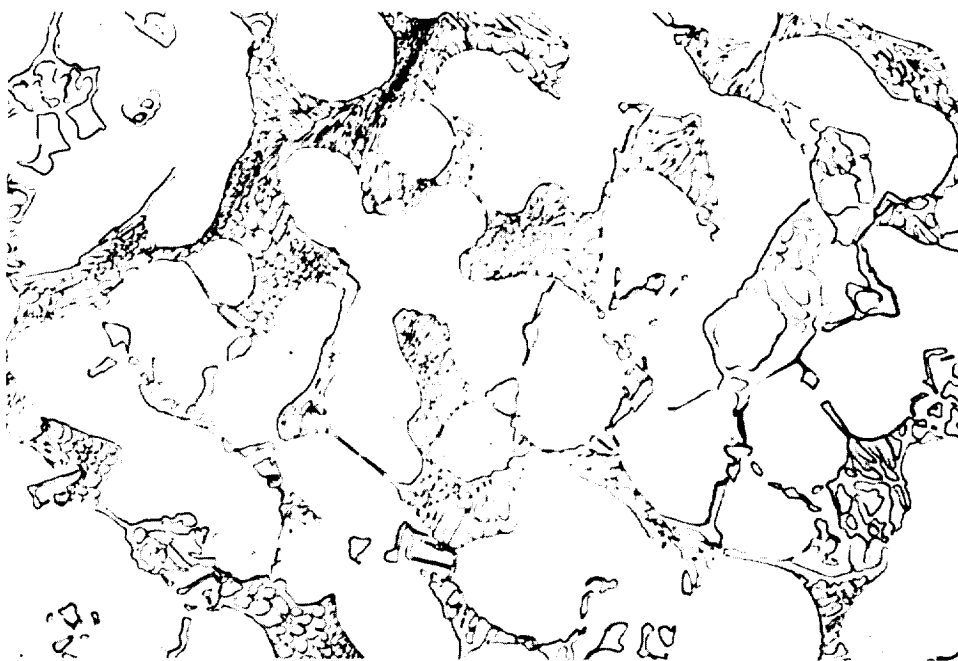
Figure 11. - Concluded. Typical as-cast structures of alloys. Etchant, 20 cc water, 20 cc glycerine, 10 cc nitric acid, and 5 cc hydrogen fluoride.

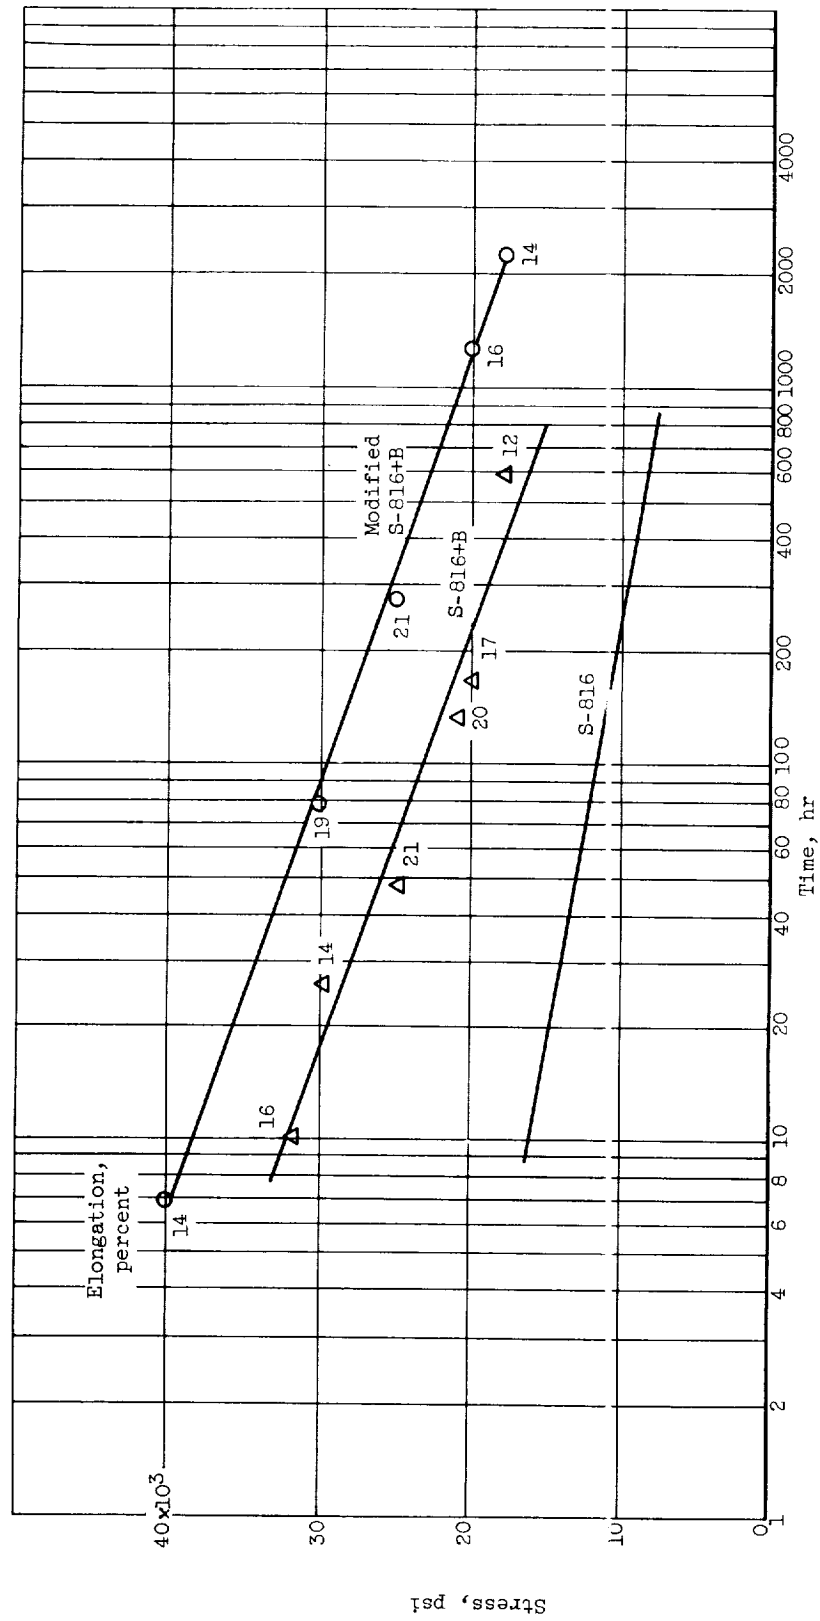
The stress-rupture results obtained for both alloys at 1650° F are shown in figure 13 and table I. As a basis for comparison, the stress-rupture data for standard S-816 at 1650° F are also shown. The latter curve was interpolated from unpublished 1600° and 1700° F data. From this figure it is evident that both S-816+B and modified S-816+B are greatly superior to standard S-816 in stress-rupture strength. The 100-hour rupture strengths at 1650° F for S-816, S-816+B, and modified S-816+B are respectively 12,000, 23,500, and 29,500 psi. The percentage elongation is also shown in figure 13. A considerable amount of intergranular cracking was observed in the test sections of the stress-rupture bars, and this contributed to the high elongation measurements.

The relatively large amount of impact damage is contrary to what might have been expected from the elongation data obtained from stress-rupture and tensile tests at 1650° F (fig. 13 and table II). These indicated considerable ductility. Also, the Izod impact tests at 1650° F (table III) indicated that the two alloys were only slightly weaker than Guy alloy in impact strength. While its impact strength was not particularly high, Guy alloy had displayed satisfactory impact resistance during engine operation (ref. 1), as noted previously. Possible inaccuracies in the laboratory test impact data due to the testing methods employed, as mentioned in the procedure section, could perhaps account for some deviation from expected behavior. A more reasonable explanation of the apparent anomaly might be made if more were known about the effect on impact resistance of the impact velocities in the engine and those encountered in the test apparatus. The impact resistance of the S-816+B alloys may have been more adversely affected by increased impact velocity than was the impact resistance of Guy alloy. Perhaps the room-temperature low-velocity laboratory impact tests of the alloys provide a better indication of their relative impact resistance under elevated-temperature high-velocity engine impact conditions than do elevated-temperature low-velocity laboratory tests. As noted earlier, the room-temperature impact strengths of the two S-816+B alloys were about half that of Guy alloy (table III). If the foregoing postulation were valid, the impact damage observed in the engine tests with the two S-816+B alloys as compared with Guy alloy would be reasonable.

Figure 13. - Stress-rupture lives and elongation at 1650° F for alloys.
